Critical Issues Analysis

Heartland Port Project

Prepared for
Heartland Port Authority

August 2021

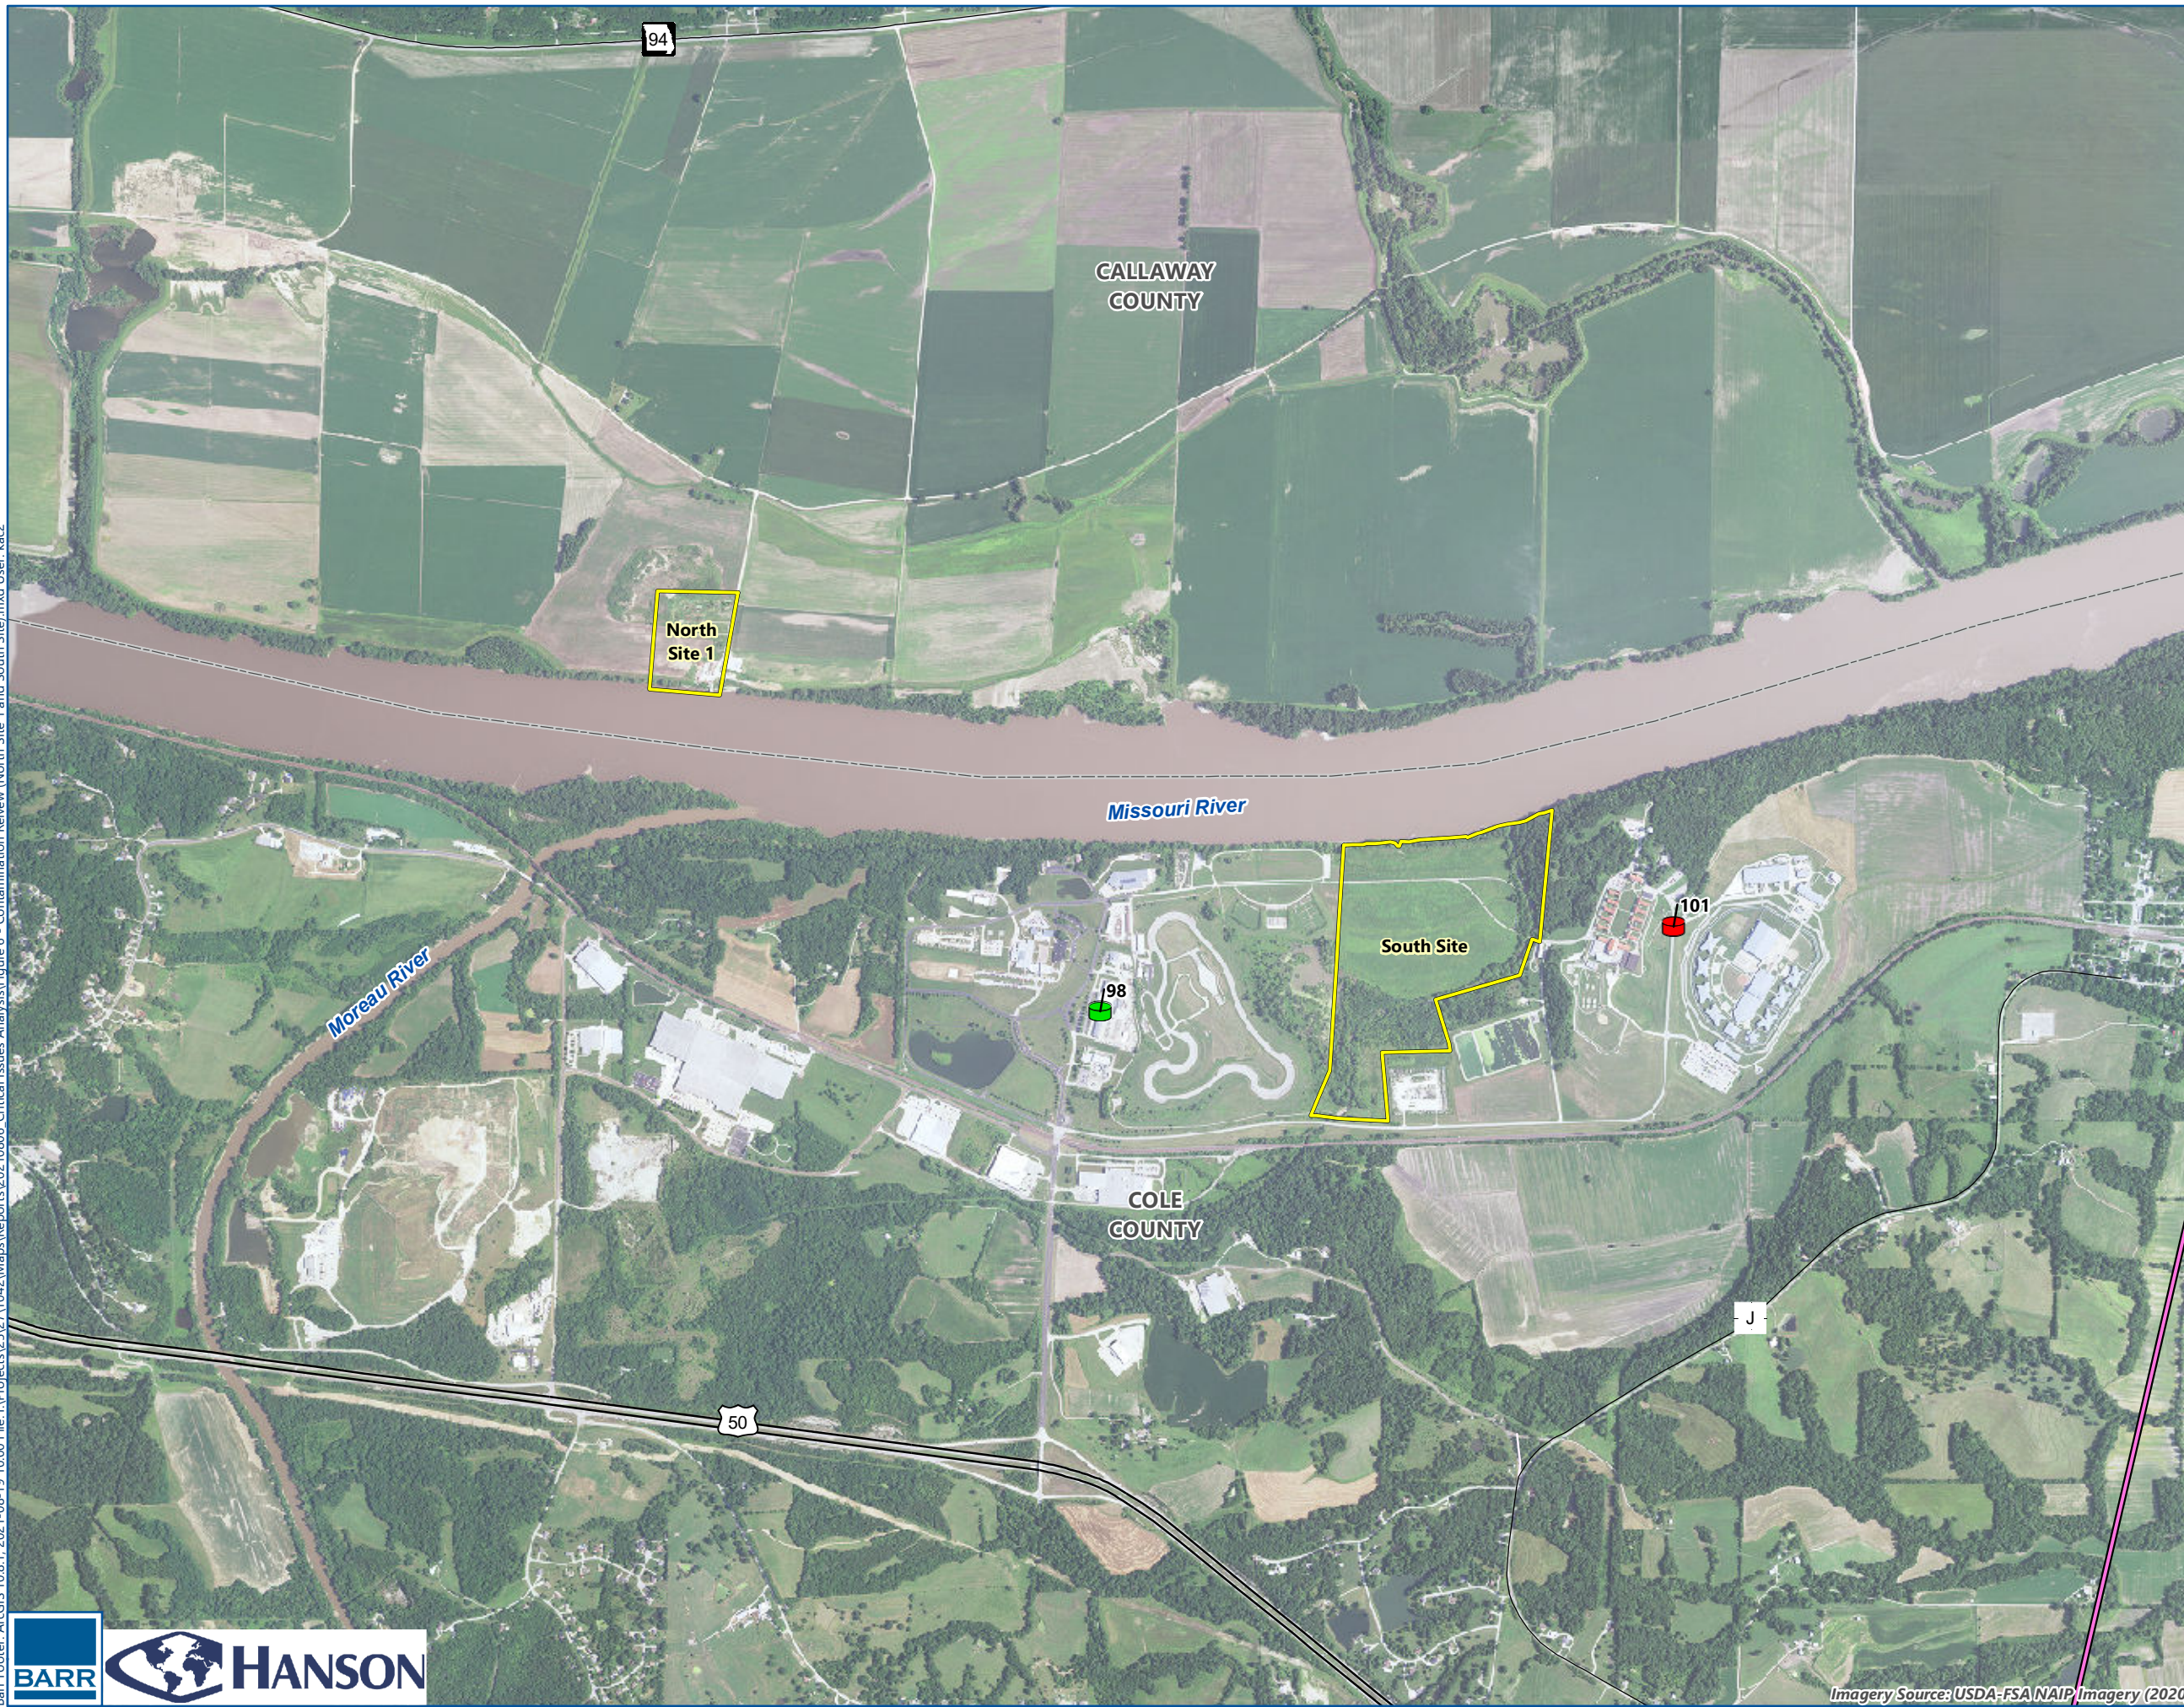
FIGURE 6

CONTAMINATION REVIEW
(NORTH SITE 1 AND SOUTH SITE)
Heartland Port Authority
Cole and Callaway
County, MO

Barr recommends a Phase I Environmental Site Assessment to determine whether Recognized Environmental Conditions (RECs) have occurred associated with the brownfield sites, active hazardous cleanup sites, or UST facilities with ongoing or incomplete investigations/corrective actions near the Project sites as illustrated in Figure 6 and Figure 7.

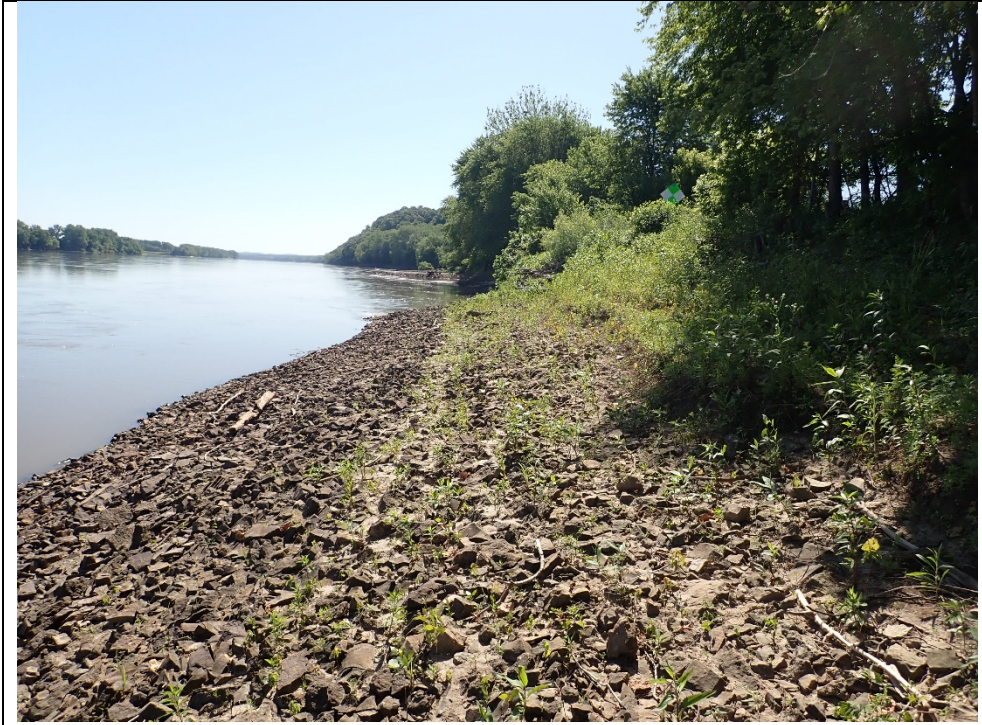
Photo 1: SSMR Missouri River shoreline with vegetation lines, downstream

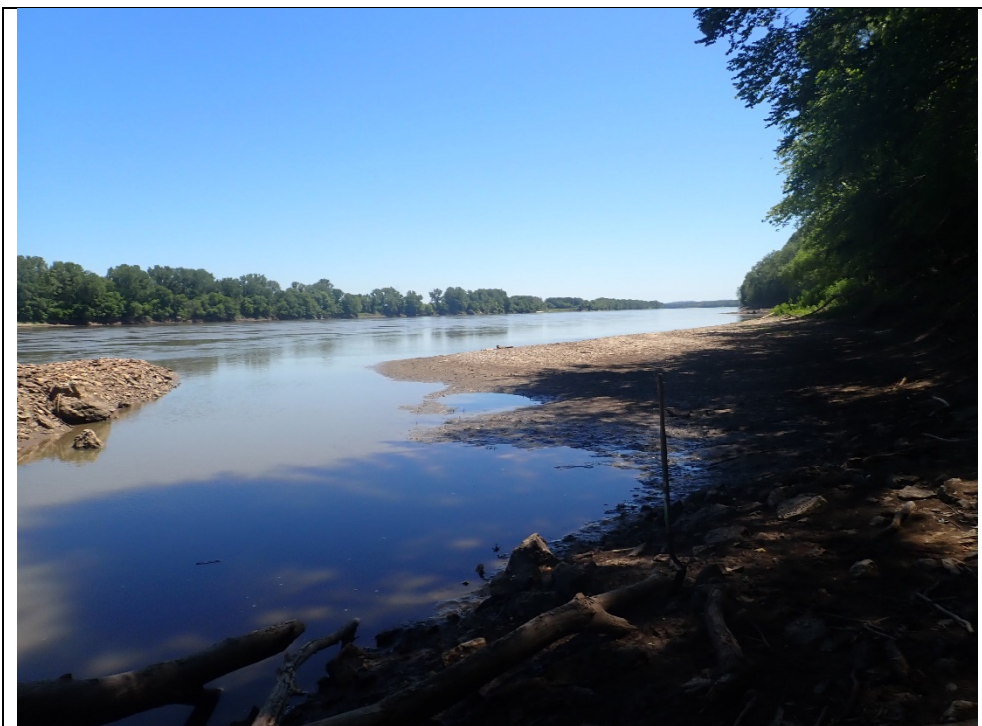
Photo 2: SSMR Missouri River shoreline and jetty (possible USACE river structure), downstream

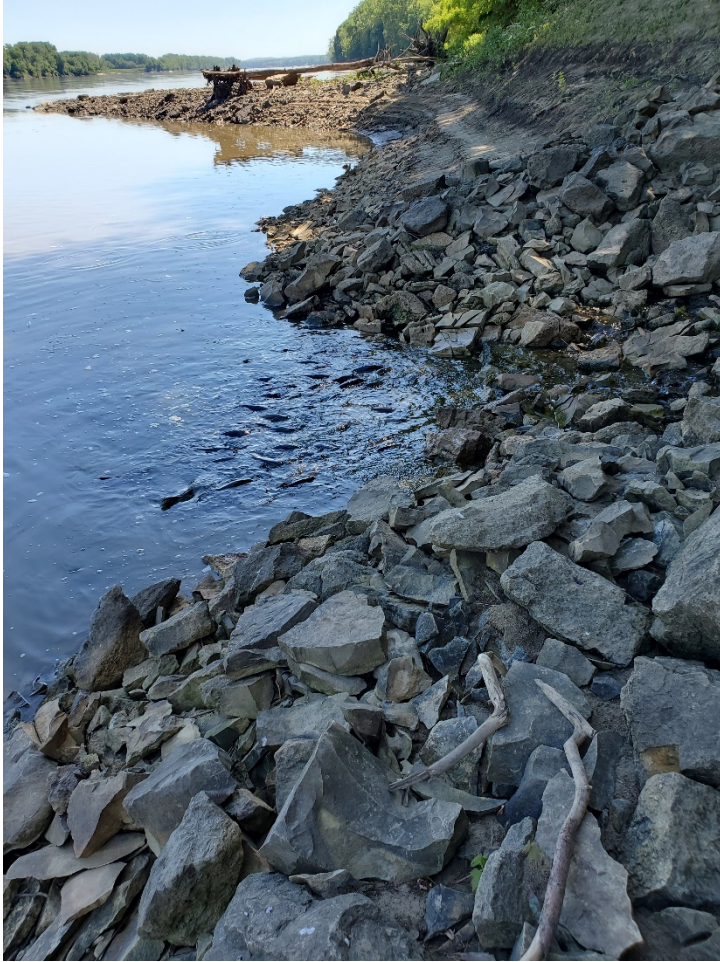
Photo 3: SSMR Missouri River rocky shoreline (possible USACE river structure in background), downstream

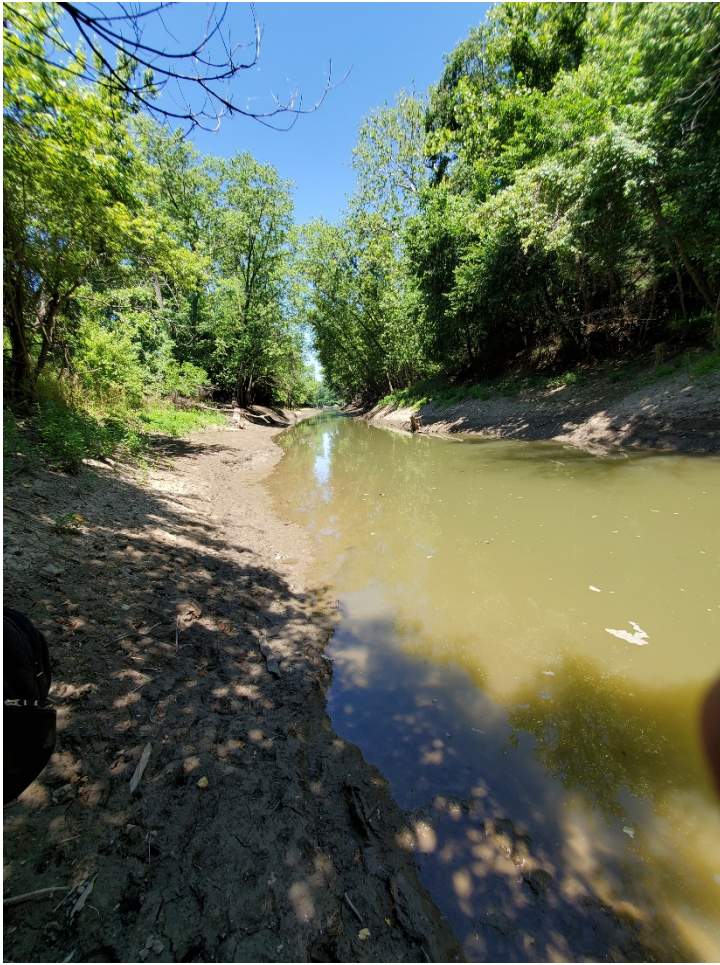
Photo 4: SCK North end of Rising Creek near Missouri River, downstream.

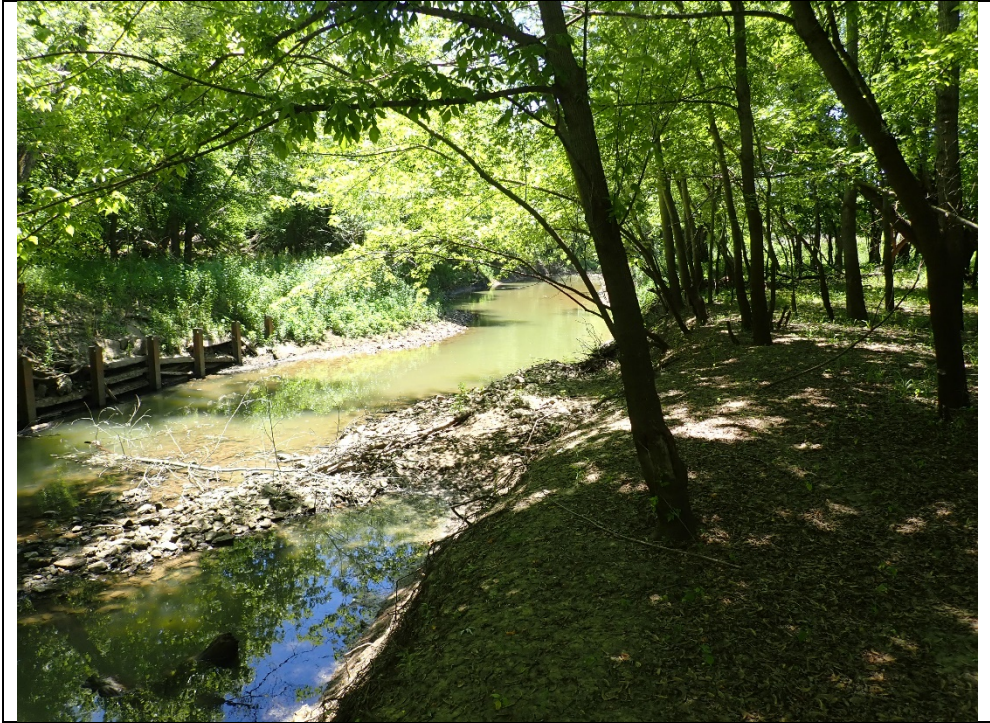
Photo 5: SSCK Rising Creek near South Site bridge, upstream

The South Site currently contains a bridge that crosses Rising Creek and a paved road on the northern portion of the site. Both features are in poor condition and will likely need to be substantially repaired or replaced. The 2003 aerial of the South Site shows evidence of a linear feature extending from a wastewater facility, located south of the site, crossing through the South Site, and apparently terminating at the Missouri River. During a June 2021 site visit, Barr observed an outfall pipe marked as wastewater treatment discharge in the vicinity of the terminus of the linear feature observed in the 2003 aerial. Furthermore, Barr observed two manholes adjacent to Rising Creek that were also identified as wastewater lines. Based on the 2003 aerial and observed wastewater manholes and discharge on the South site, it is evident that a wastewater pipeline crosses under the site. The depth, size, and exact location of the pipeline are uncertain currently, however, the presence of this infrastructure may pose a constraint in developing or require utility relocation as part of site development for the South Site.

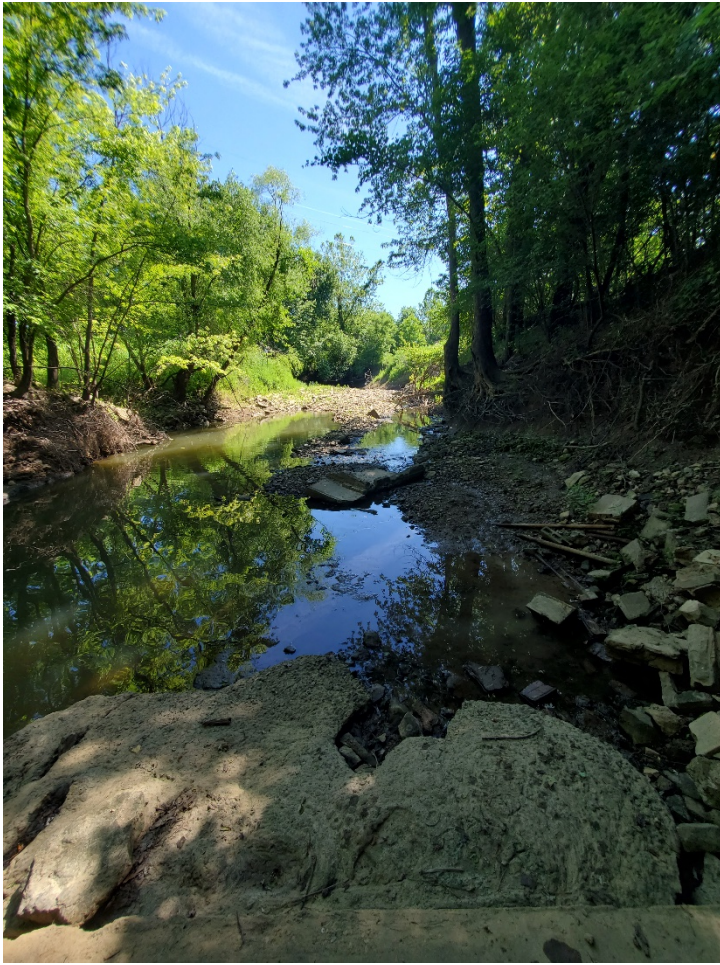
Photo 6: SSCK Rising Creek where it enters the South Site through a concrete box culvert, downstream

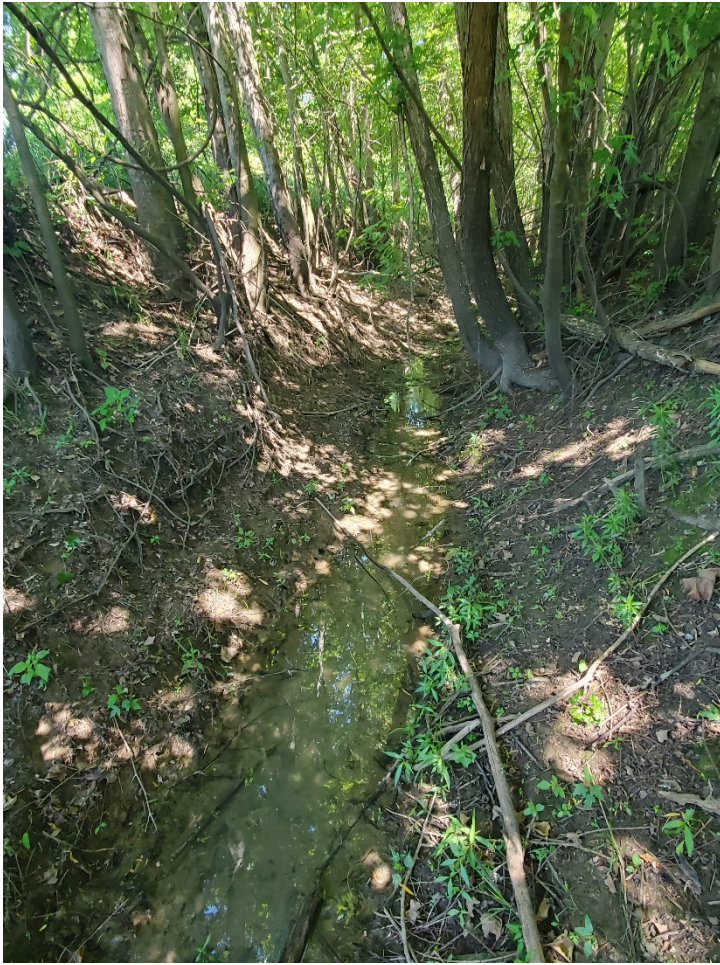
Photo 7: SSCK Side channel draining to Rising Creek on southeast side of South Site, upstream

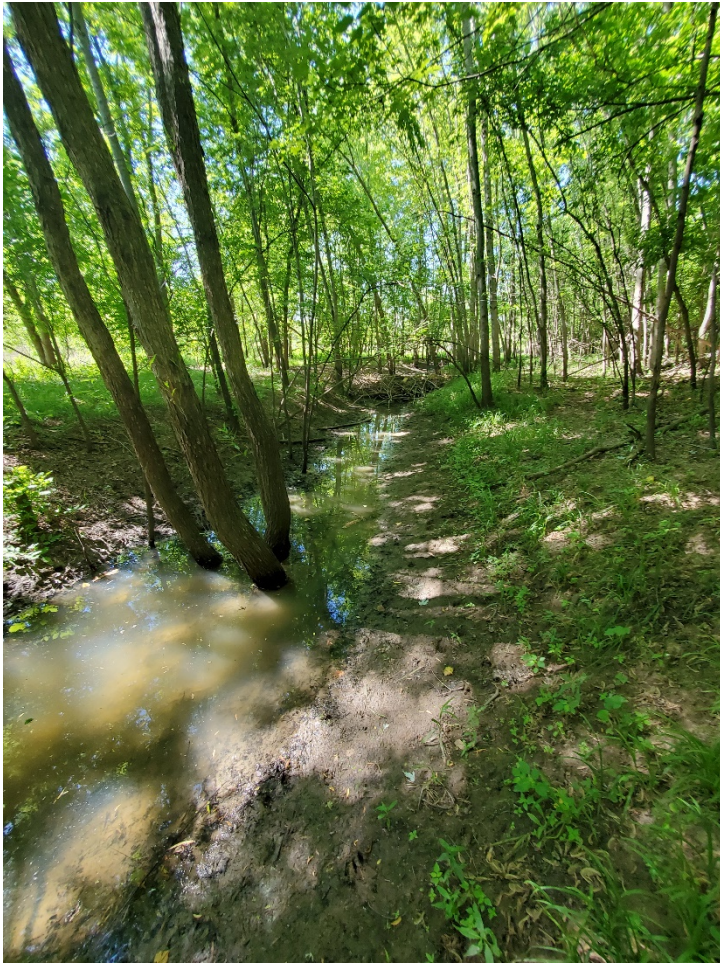
Photo 8: SSSC Side channel that appears to drain beaver-created ponds to the east, upstream

Several functioning and non-functioning beaver-created ponds were observed on the southwest border that impounded a large area of standing water. The large area of inundation appears to have been sustained for a substantial duration as soils had taken on the characteristics of hydric conditions and vegetation that prefer and thrive in wet conditions had been established, meaning the area met the requirements of a wetland. The beaver pond influenced area encompassed approximately 3.06 acres on the southwest border of the site and extended off site to the adjacent property. This area includes the beaver pond inundation area (SSBP, 2.78 acres), a channel that appears to drain the beaver pond area to the east (SSSC, 0.13 acres) and a channel that appears to drain the beaver pond area to the south (SSBW, 0.15 acres).

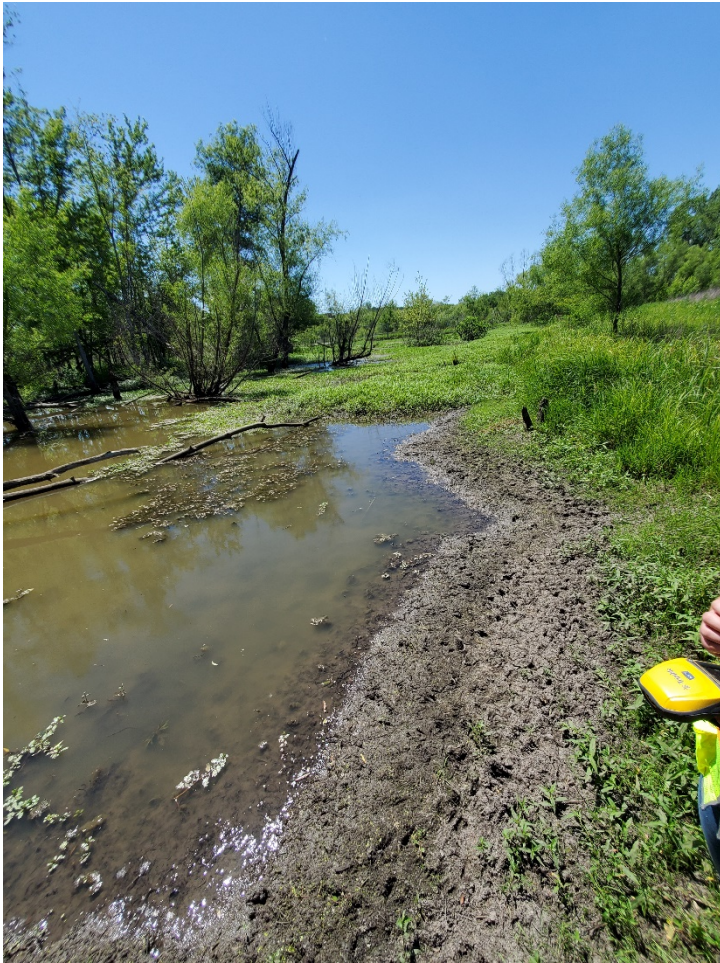
Photo 9: SSBP Northwest corner of beaver-created ponds on the southwest side of the South Site

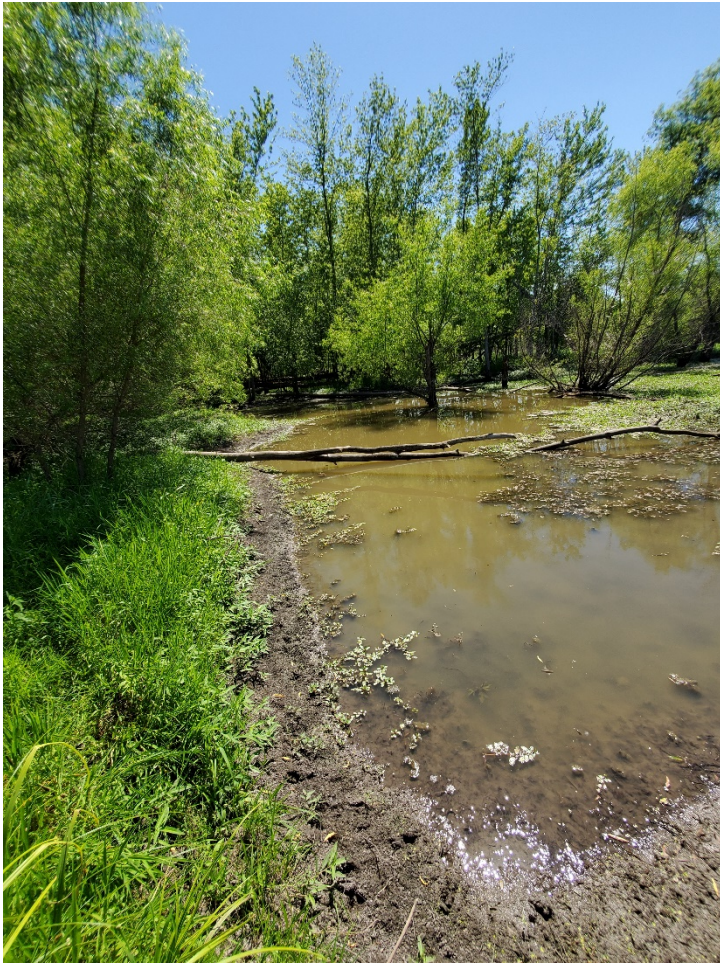
Photo 10: SSBP East side of beaver-created pond on the southwest side of the South Site.

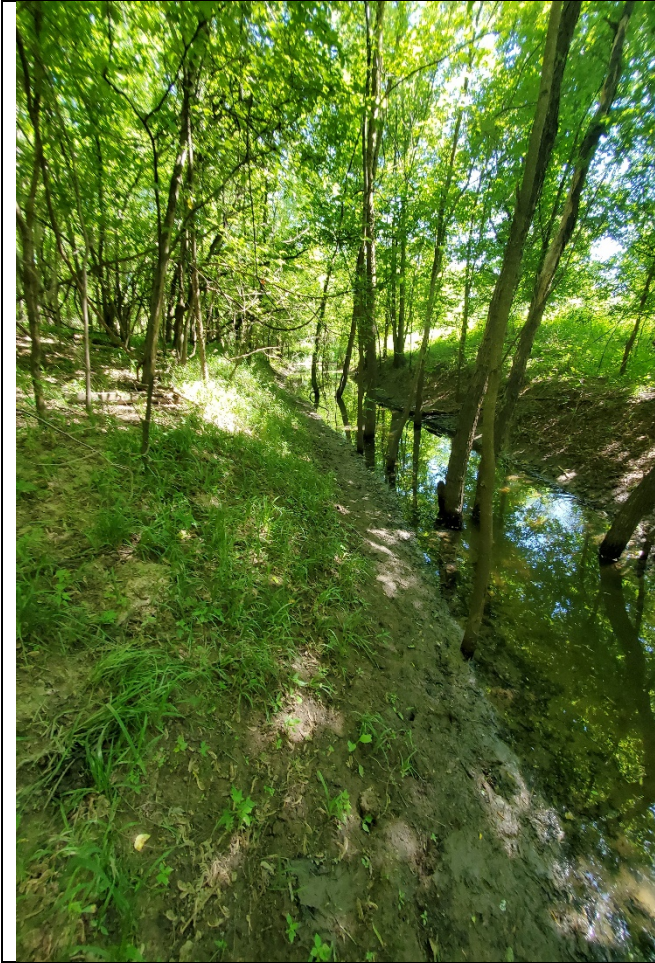
Photo 11: SSBW Backwaters that appear to drain beaver-created pond to the south

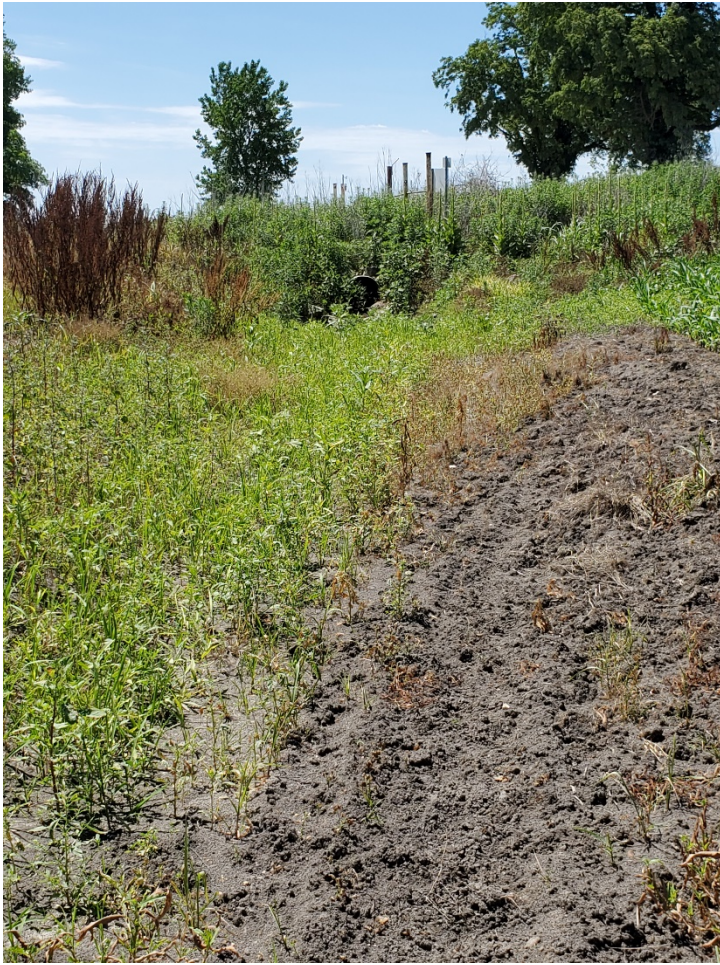
Photo 12: 4033 Upland edge of an agricultural field next to County Road 4033
